2015 Monitoring Summary

Scarham Creek at Dekalb County Road 28 (34.30261/-86.02032)

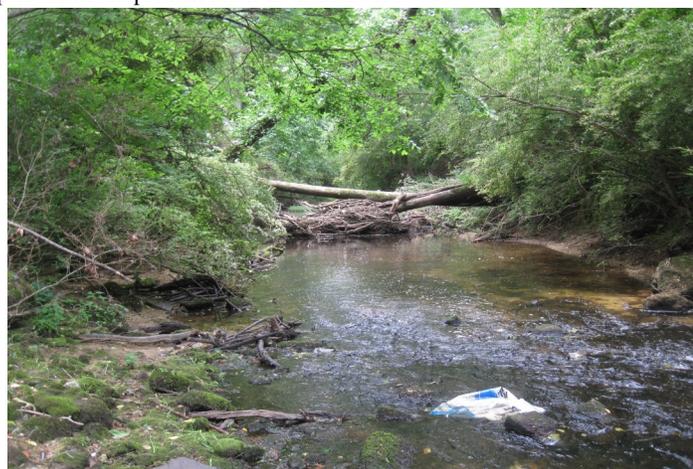
Figure 1. Scarham Creek at SHMD-2, August 12, 2015.

General observations (Table 3) and a habitat assessment (Table 4) were completed during the macroinvertebrate assessment. In comparison with reference reaches in the same ecoregion, they give an indication of the physical condition of the site and the quality and availability of habitat. Overall habitat quality was rated as *sub-optimal*. However, sand and silt comprised 68% of bottom substrates within the reach.

Biological survey results indicated the macroinvertebrate community in Scarham Creek at SHMD-2 to be in *fair* condition, and overall habitat quality to be *sub-optimal*. However, the reach was characterized by a high percentage of sand and silt for a stream in ecoregion 68d.
